# Manhole Inspection Summary

Manhole # S21GG2022MH

Insp Date: **3/12/08 11:47 AM**

**Location** Address: **1115 HARRINGTON RD**

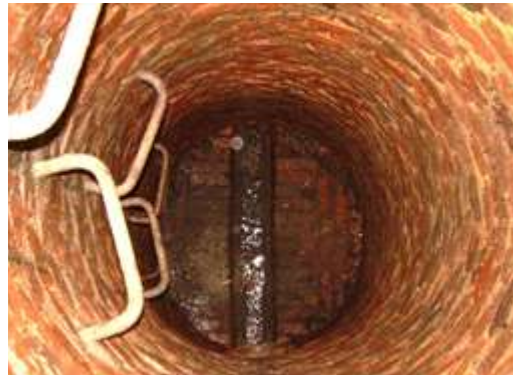
Top View

Corroded steps. Bench and Channel debris.

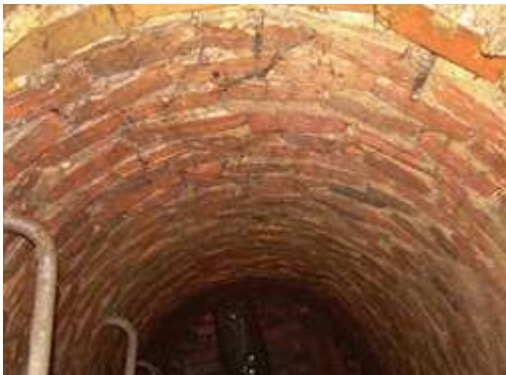
Defect

Corbel and Barrel infiltration.

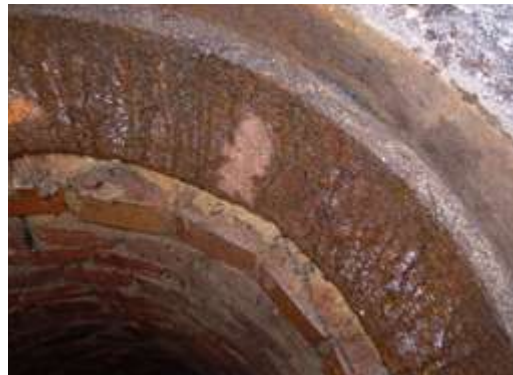
Defect

Frame leaks. Corbel deterioration and infiltration.

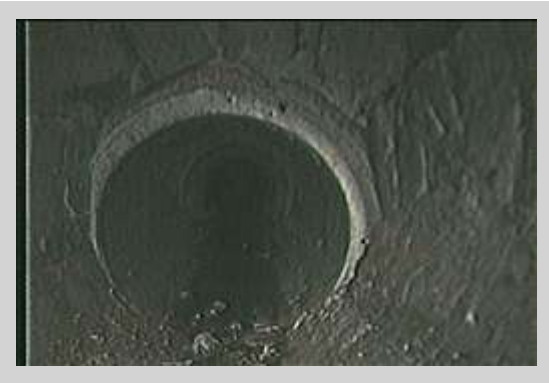
### 8 in. Circular Gravity Sewer Pipe Out @ 12 O'Clock

Pipe Material: **Clay** ☐ Pipe Lined

Invert Depth: **12.90** (ft.) Flow Characteristics: **Slow**

Deposits: ☒ None ☐ Mud ☐ Sludge ☐ Debris ☐ Grease

Infiltration: **None** Pipe Seal Cond: **Unknown**

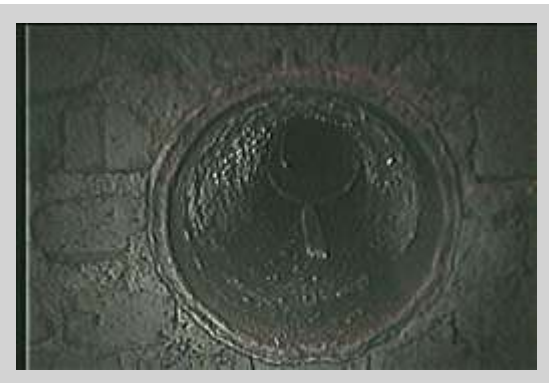
### 8 in. Circular Gravity Sewer Pipe In @ 6 O'Clock

Pipe Material: **Clay** ☐ Pipe Lined

Invert Depth: **8.20** (ft.) Flow Characteristics: **Slow**

Deposits: ☒ None ☐ Mud ☐ Sludge ☐ Debris ☐ Grease

Infiltration: **None** Pipe Seal Cond: **Unknown**

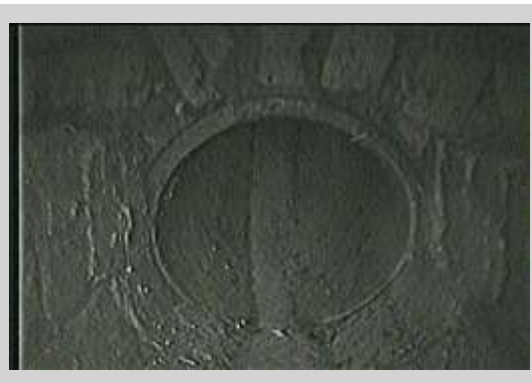
### Drop In @ 6 O'Clock

Drop: **Outside** Rod and Bar

Angled: **Yes** Reading: **11.40** (ft.)

Inv Depth: **12.40** (ft.)

Drop Condition: **Open**
